**Zeitschrift:** Swiss express : the Swiss Railways Society journal  
**Herausgeber:** Swiss Railways Society  
**Band:** 4 (1994-1996)  
**Heft:** 5

**Artikel:** Inching along through the Lötschberg tunnel  
**Autor:** Hoekstra, George M.  
**DOI:** <https://doi.org/10.5169/seals-855030>

## Inching Along Through the Lötschberg Tunnel

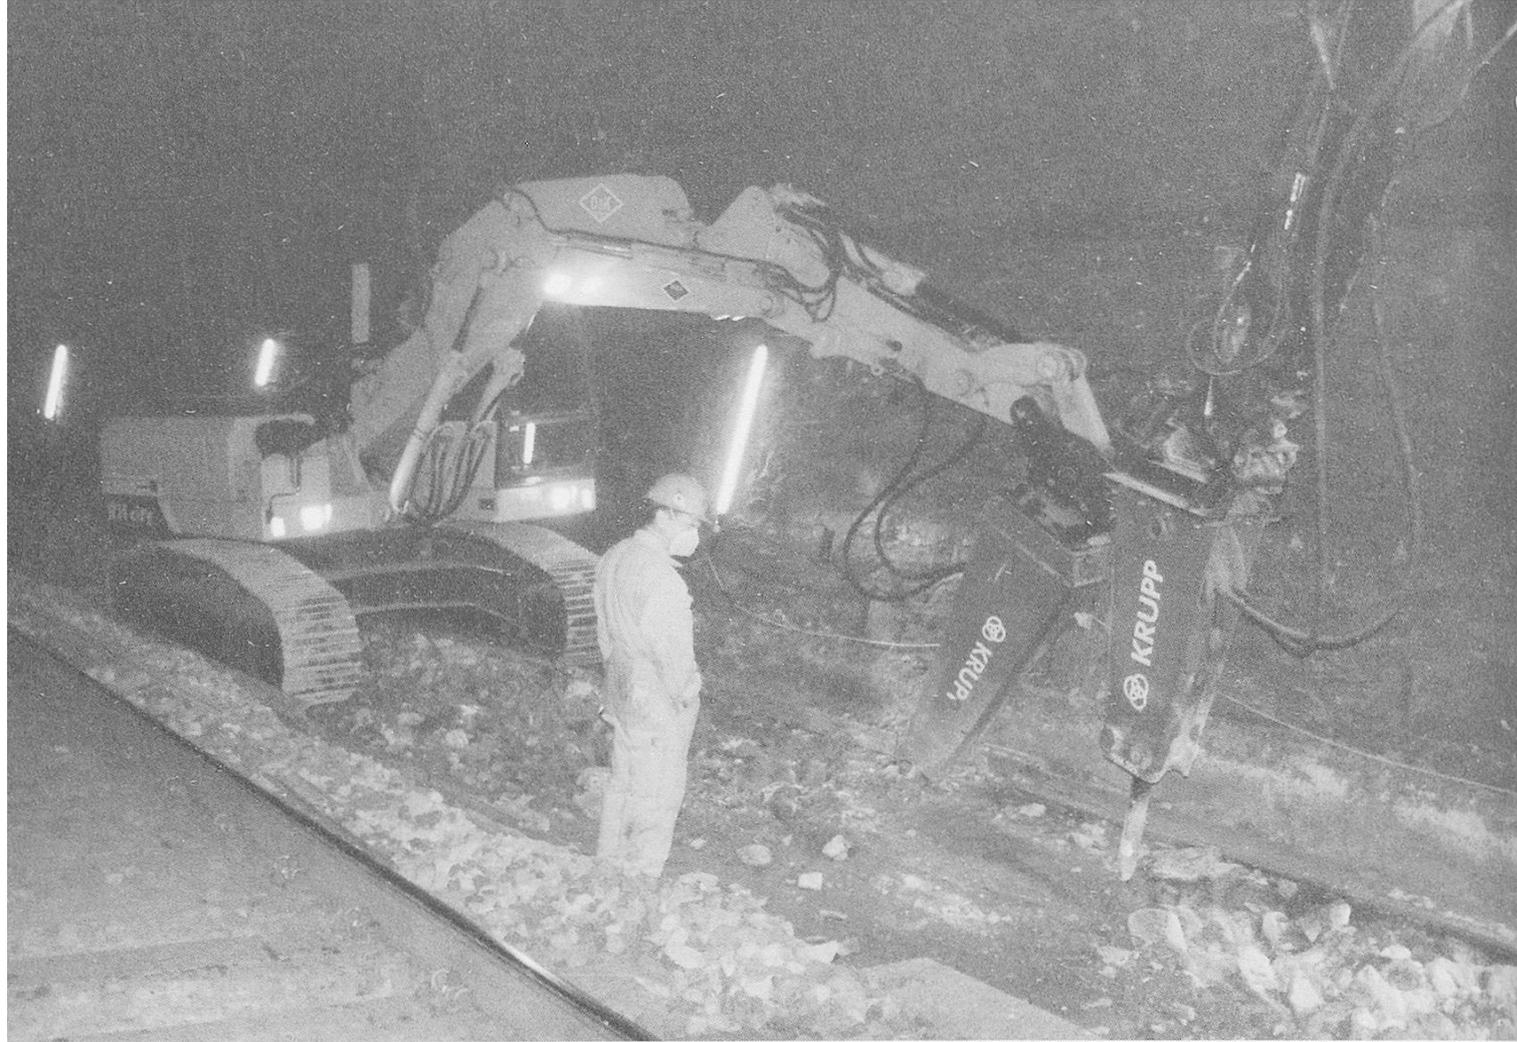
Lowering the track base with hydraulic hammer drill. Note how close the running tracks are to the work site.

The right-hand track is worked on initially. The track is cut into sections 18 m long, lifted and removed from the tunnel. Useable sleepers are stored. Then the old ballast is removed and the rock floor of the tunnel is lowered. All this spoil is loaded by a conveyor belt into waiting hopper wagons. The work is extremely dusty, so apart from the operators wearing special *Airstream* masks and other personnel wearing face dust masks, the BLS has installed a special vacuum cleaner wagon, capable of filtering 120,000 cubic metres of air each eight hour shift. No less that 12 kilogrammes of very
