Zeitschrift:	Swiss express : the Swiss Railways Society journal
Herausgeber:	Swiss Railways Society
Band:	5 (1997-1999)
Heft:	1
Artikel:	Track relaying on the MOB (Montreux-Oberland-Bernois)
Autor:	Heath, Les
DOI:	https://doi.org/10.5169/seals-854470

Track relaying on the MOB (Montreux-Oberland-Bernois)

by Les Heath Photographs by author

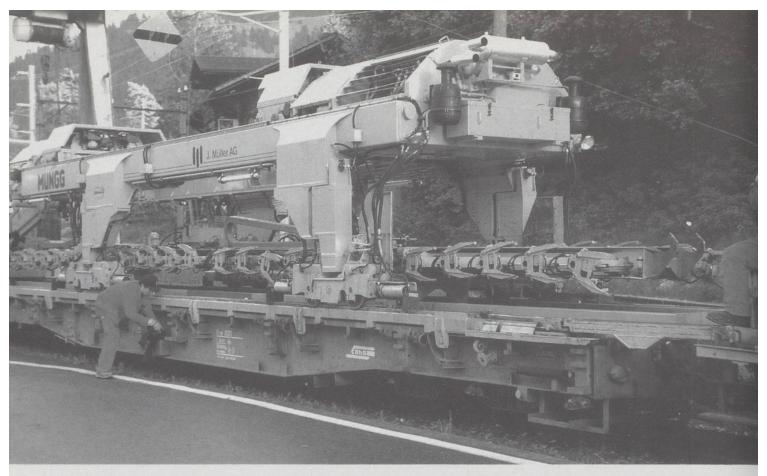
Above: The crane with the lifting spar the fork arms swivel down to pick up the new sleepers. Below: An old section of track being lifted, the new replacement rail can been seen next to the ballast waiting lifting onto the new sleepers. The lifting spar is suspended between the tracked crane and the wagon mounted crane. Note the new sleeper on the left having been dropped with the previous section.

wagon crane was then positioned over the concrete sleepers the spar unit had claws that were turned down to pick up the individual sleepers. The crane moved to the rear where the spar was reattached to the tracked crane. The spar was moved out over the empty trackbed and lowered into place. Each sleeper was moved sideways by hydraulics to ensure that the curvature of the original line is maintained. Any misalignment would affect not only the clearances side to side but also the positioning of the overhead contact line with the pantograph. Having positioned the sleepers the whole train and tracked crane move down another fifteen metres and the process was repeated; cut, lift, move, replace.

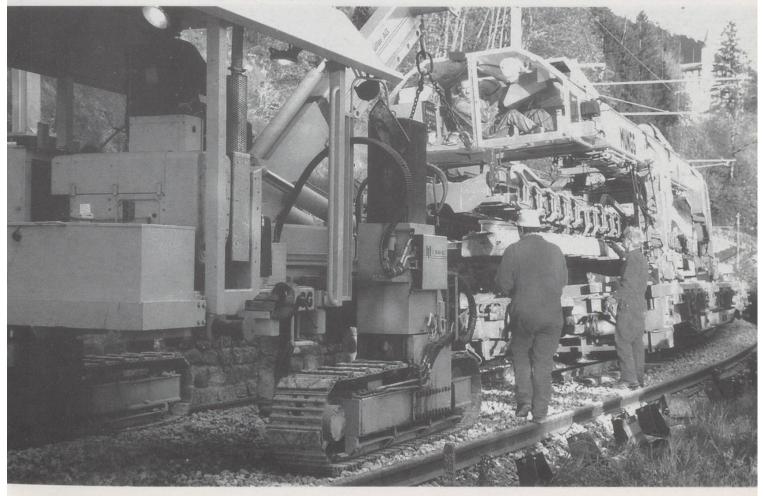
Below: A clear view of the tracked crane manouvering the spar under the wagon crane, the driver of the wagon crane is visible above spar in a semi-lying position, access is via the glass doors.

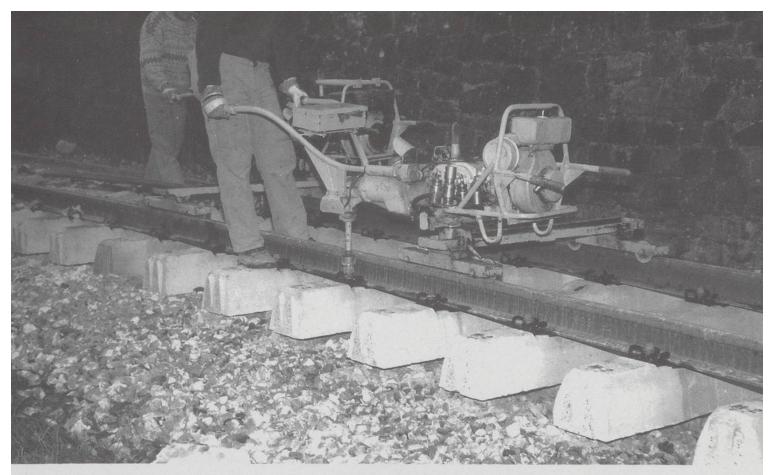
Above: These two small machines move along tightening the bolts holding down the rails.

The rails are bolted together with fishplates every sixty metres initially, but the following week the fishplates were removed and the rails are welded, finally the rail grinding train is used to profile the track.

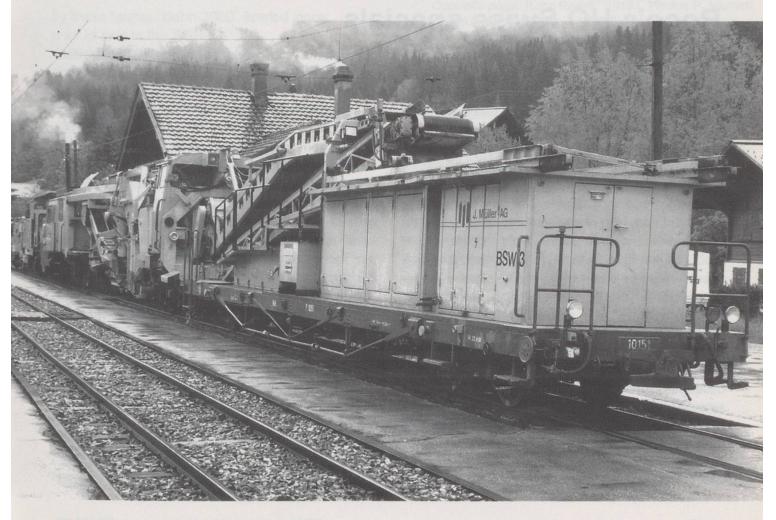
Below: The ballast cleaning and replacing train waits to follow on behind when the track crews have finished.

accomplished with a motley looking series of small machines that appeared to be precariously balanced on the track that had already been replaced. The placing of the new rail sections used a lot of manual pushing and lifting with large iron bars to manoeuvre the long lengths of rail into place, its surprising how flexible the rails appear to be. The small hydraulic machines lift and move the track to attain the correct distances from the retaining walls. Following along were two machines were used to tighten the bolts retaining the wire loops that hold down the rails. Finally the ballast cleaning train passes over the completed section settling the sleepers in place.
