**Artikel:** Track relaying on the MOB (Montreux-Oberland-Bernois)  
**Autor:** Heath, Les  
**DOI:** <https://doi.org/10.5169/seals-854470>

## Track relaying on the MOB (Montreux-Oberland-Bernois)

by Les Heath Photographs by author

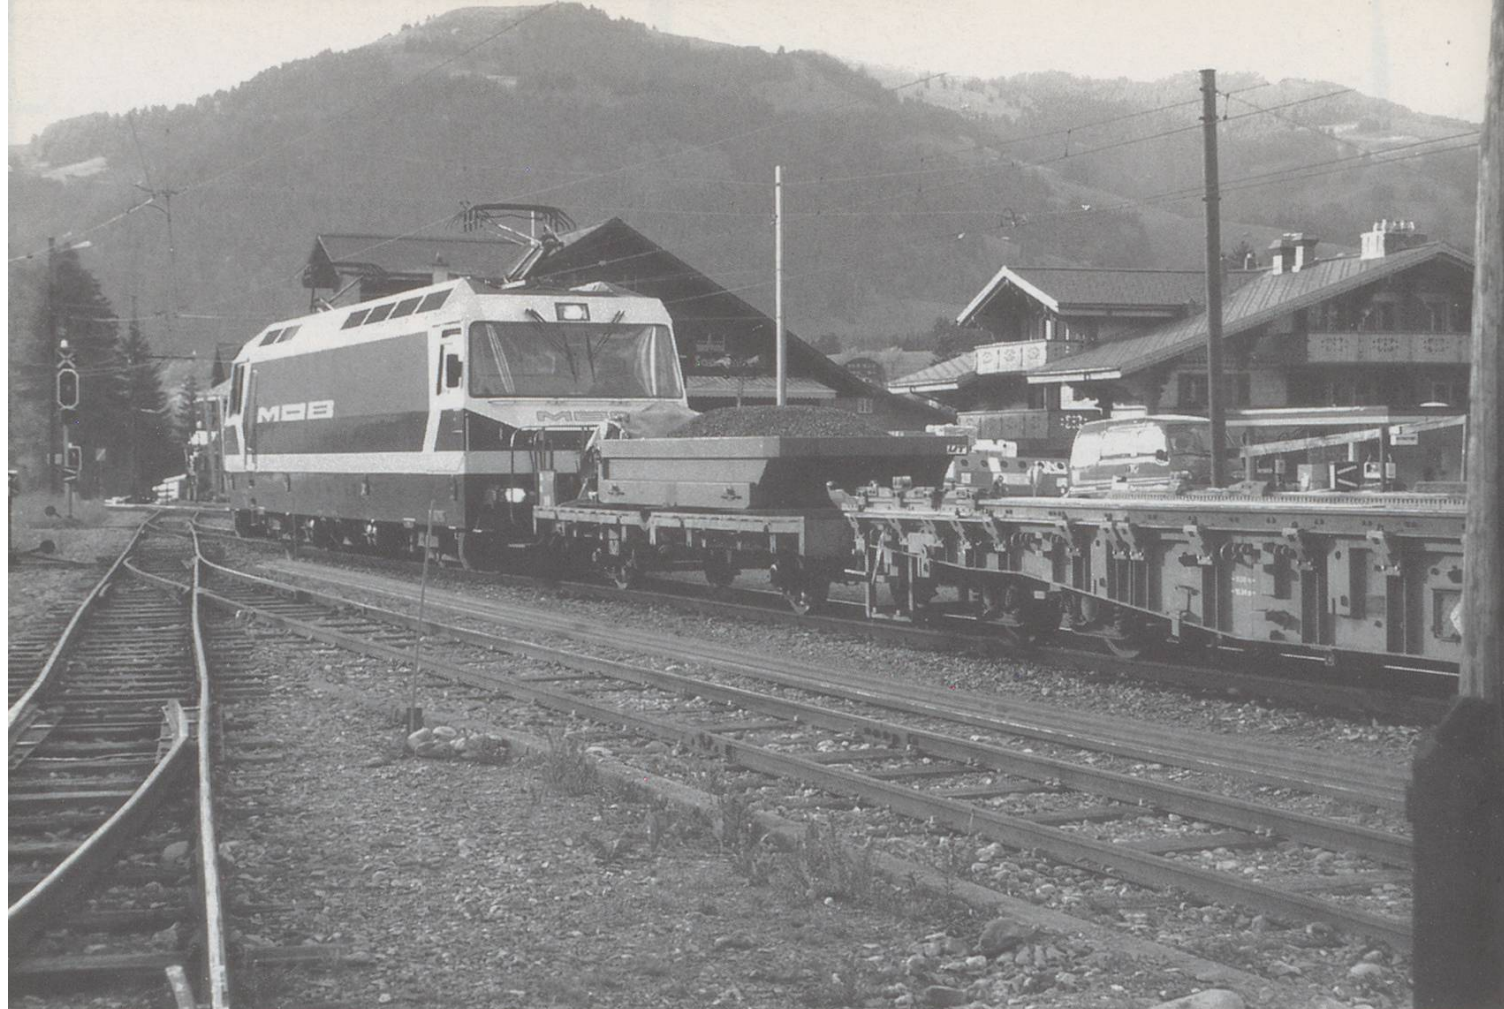
*Below:* An old section of track being lifted, the new replacement rail can be seen next to the ballast waiting lifting onto the new sleepers. The lifting spar is suspended between the tracked crane and the wagon mounted crane. Note the new sleeper on the left having been dropped with the previous section.

Laying alongside the ballast was the new replacement rail sections in sixty metre lengths, this had been dropped off earlier in the week. The first part of the operation was very mechanised, all hydraulically operated machinery with many levers and much shouting, the next part was

accomplished with a motley looking series of small machines that appeared to be precariously balanced on the track that had already been replaced. The placing of the new rail sections used a lot of manual pushing and lifting with large iron bars to manoeuvre the long lengths of rail into place, its surprising how flexible the rails appear to be. The small hydraulic machines lift and move the track to attain the correct distances from the retaining walls. Following along were two machines were used to tighten the bolts retaining the wire loops that hold down the rails. Finally the ballast cleaning train passes over the completed section settling the sleepers in place.

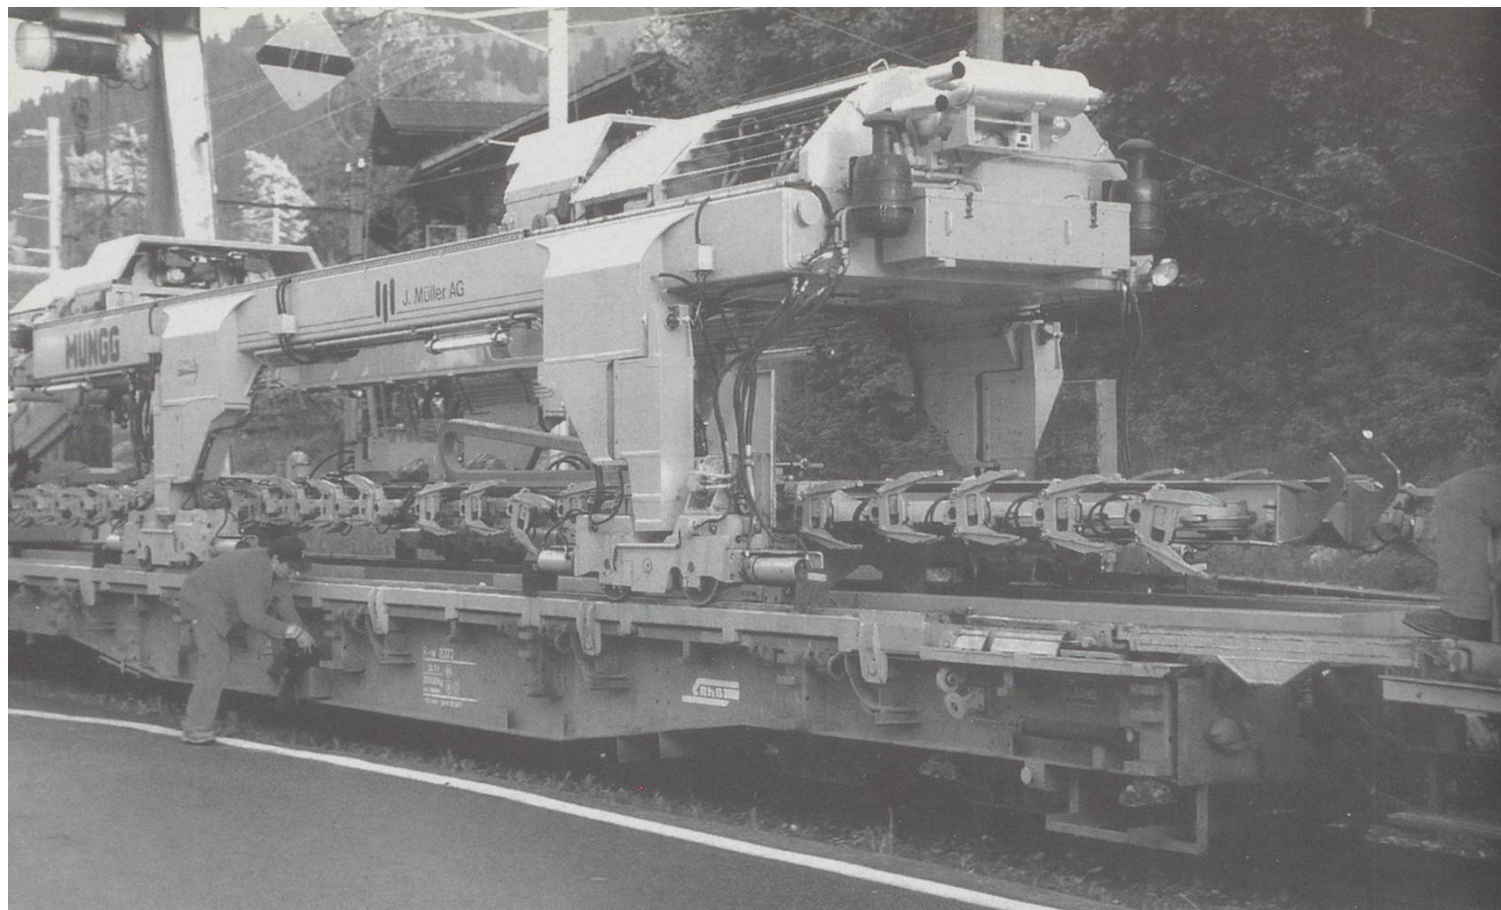
*Above:* The new concrete sleepers in place on the flat wagons, on the edges of the wagons can be seen rails for the crane to move along the length of the train whilst carrying the old track sections / new sleepers.

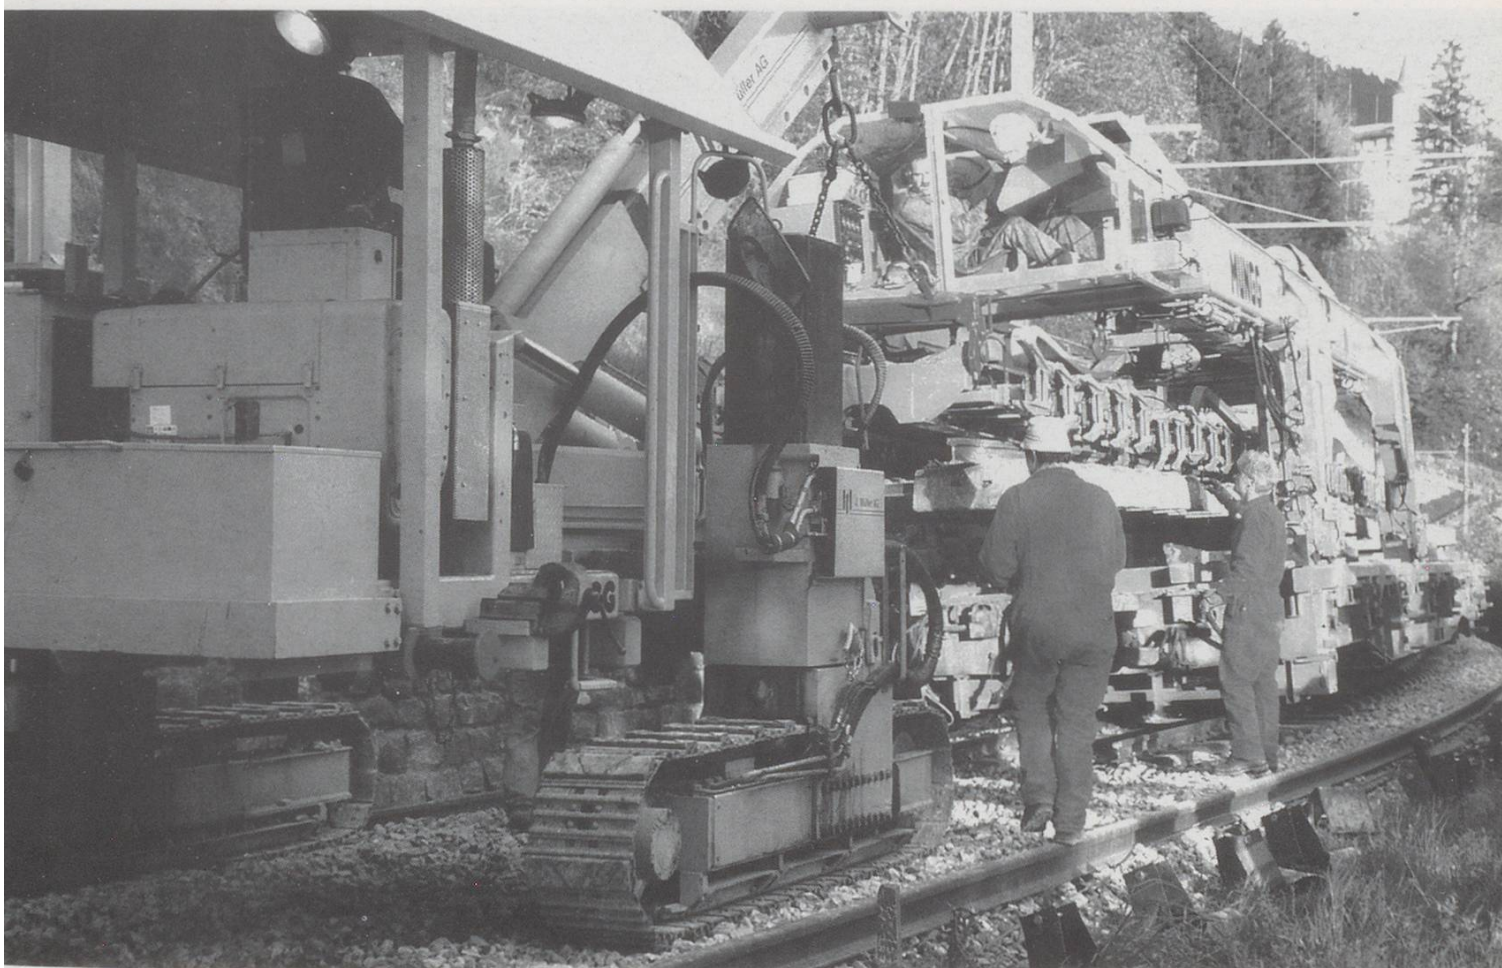
Above: The section of old track being manoeuvred under the wagon crane, to be carried along the train and placed onto one of the empty flat wagons.

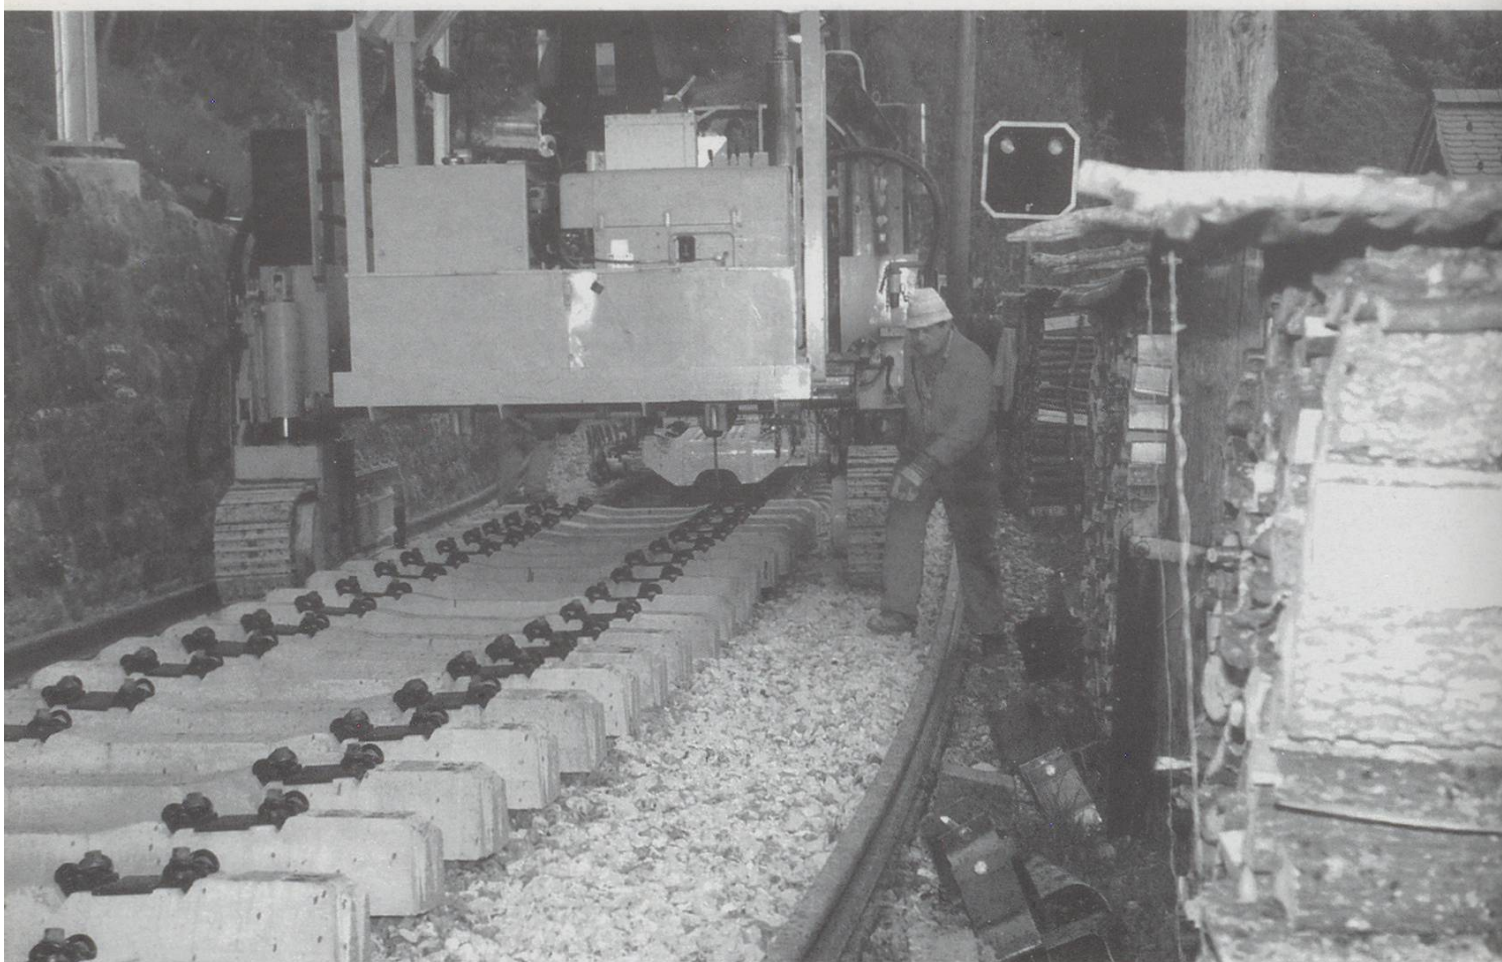
*Above:* The lifting spar with the new sleepers being dropped into place, the sleepers can be moved individually by hydraulics to shape the line.

wagon crane was then positioned over the concrete sleepers the spar unit had claws that were turned down to pick up the individual sleepers. The crane moved to the rear where the spar was reattached to the tracked crane. The spar was moved out over the empty trackbed and lowered into place. Each sleeper was moved sideways by hydraulics to ensure that the curvature of the original line is maintained. Any misalignment would affect not only the clearances side to side but also the positioning of the overhead contact line with the pantograph. Having positioned the sleepers the whole train and tracked crane move down another fifteen metres and the process was repeated; cut, lift, move, replace.

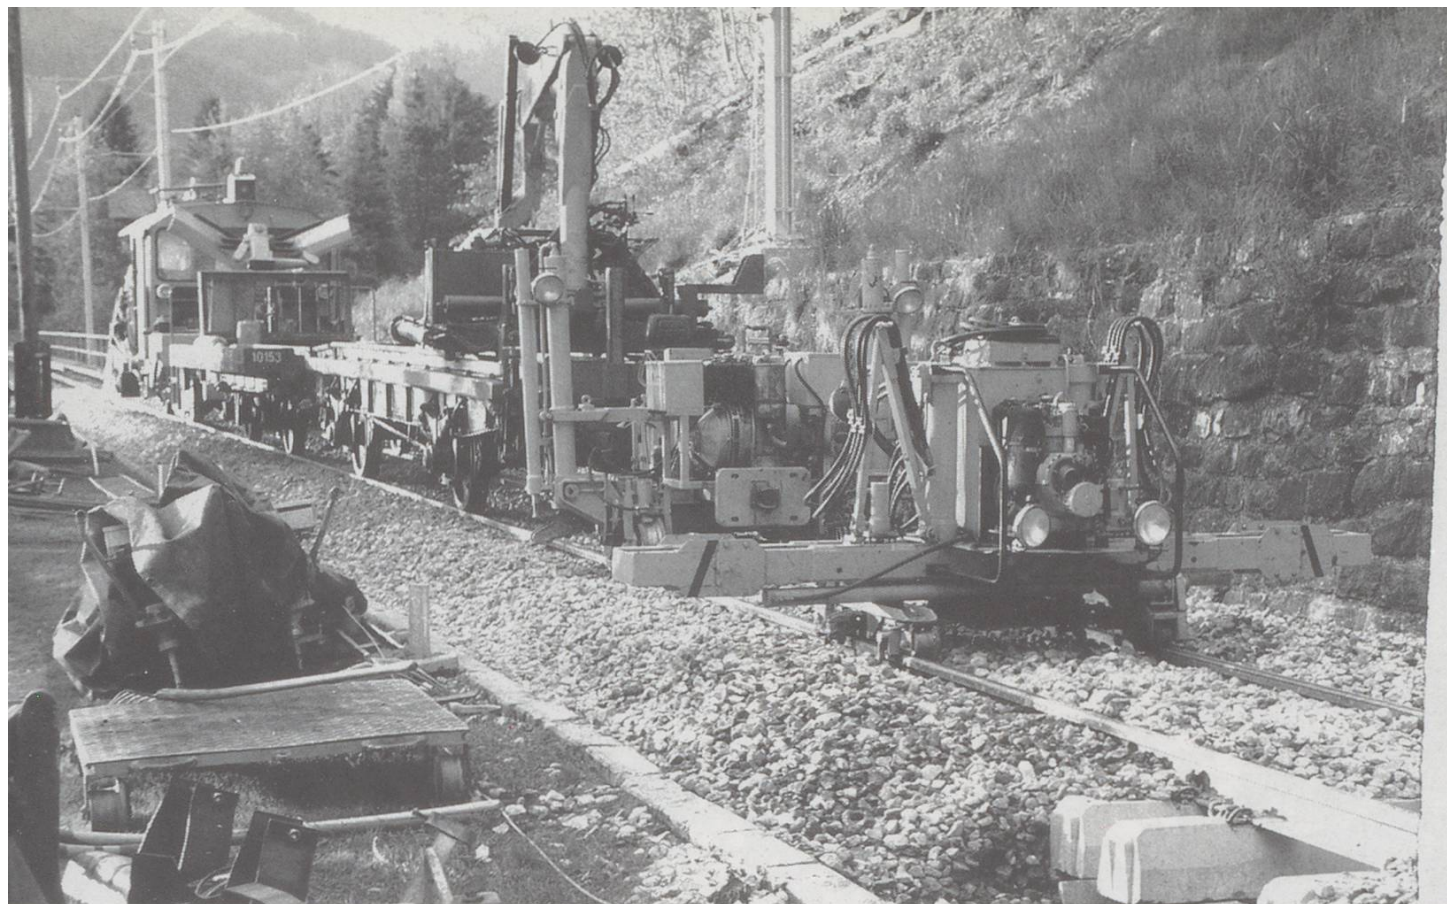
*Below:* The train and crane have moved further down the track, the new sleepers await the new track visible on the right next to the ballast. The tracks of the crane are wider than the sleepers allowing free movement.

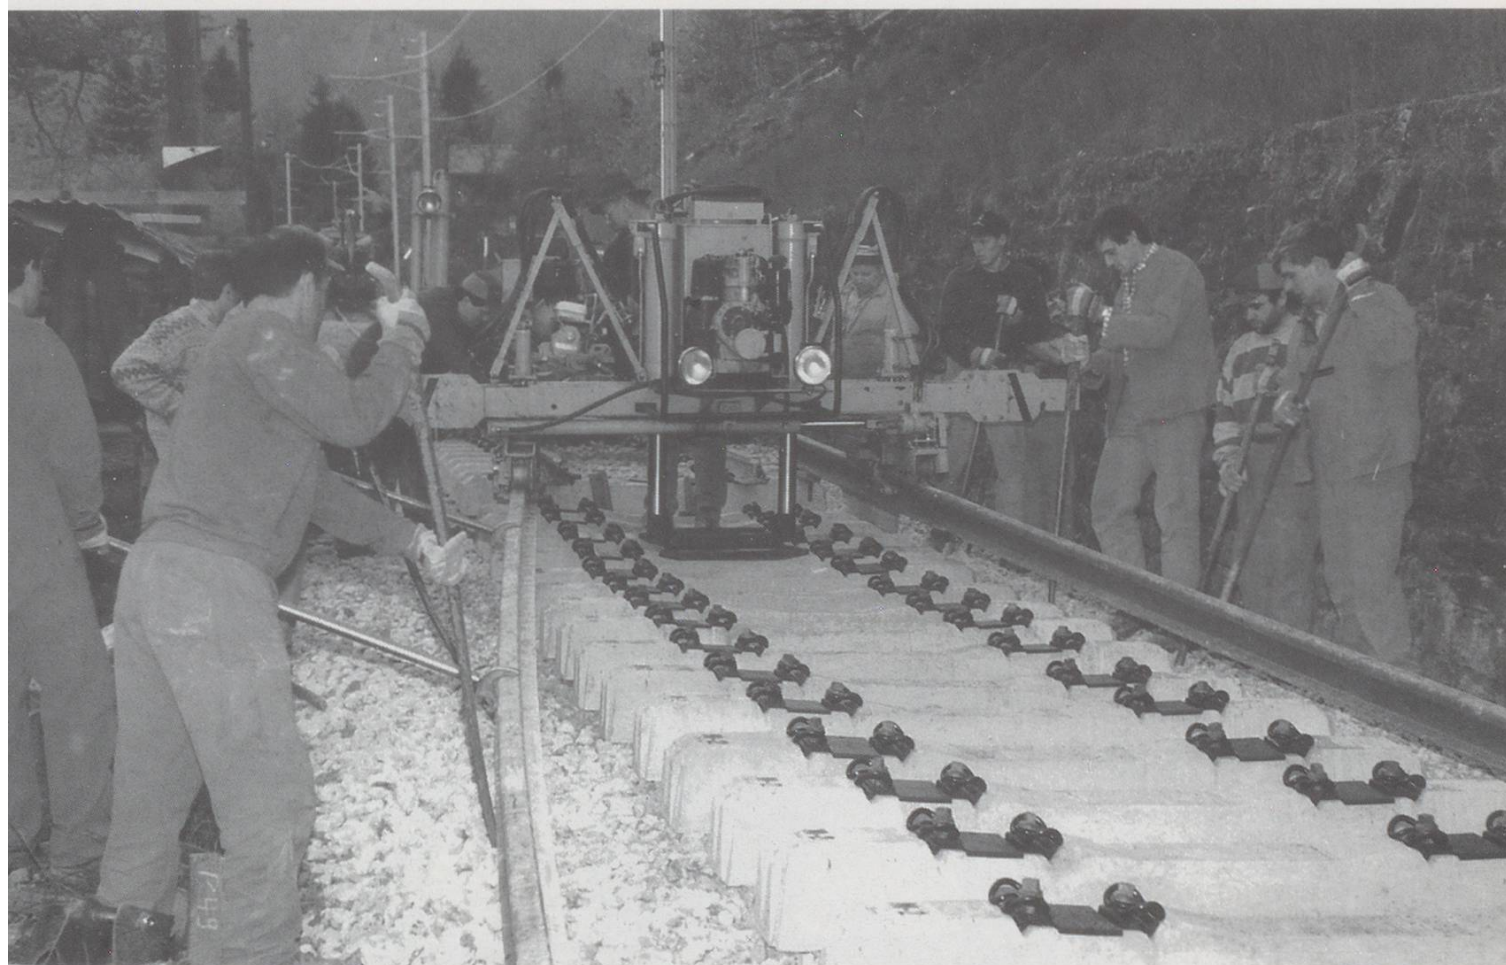
Above: The next strange looking collection of machinery awaits the cranes to move along laying the new sleepers.

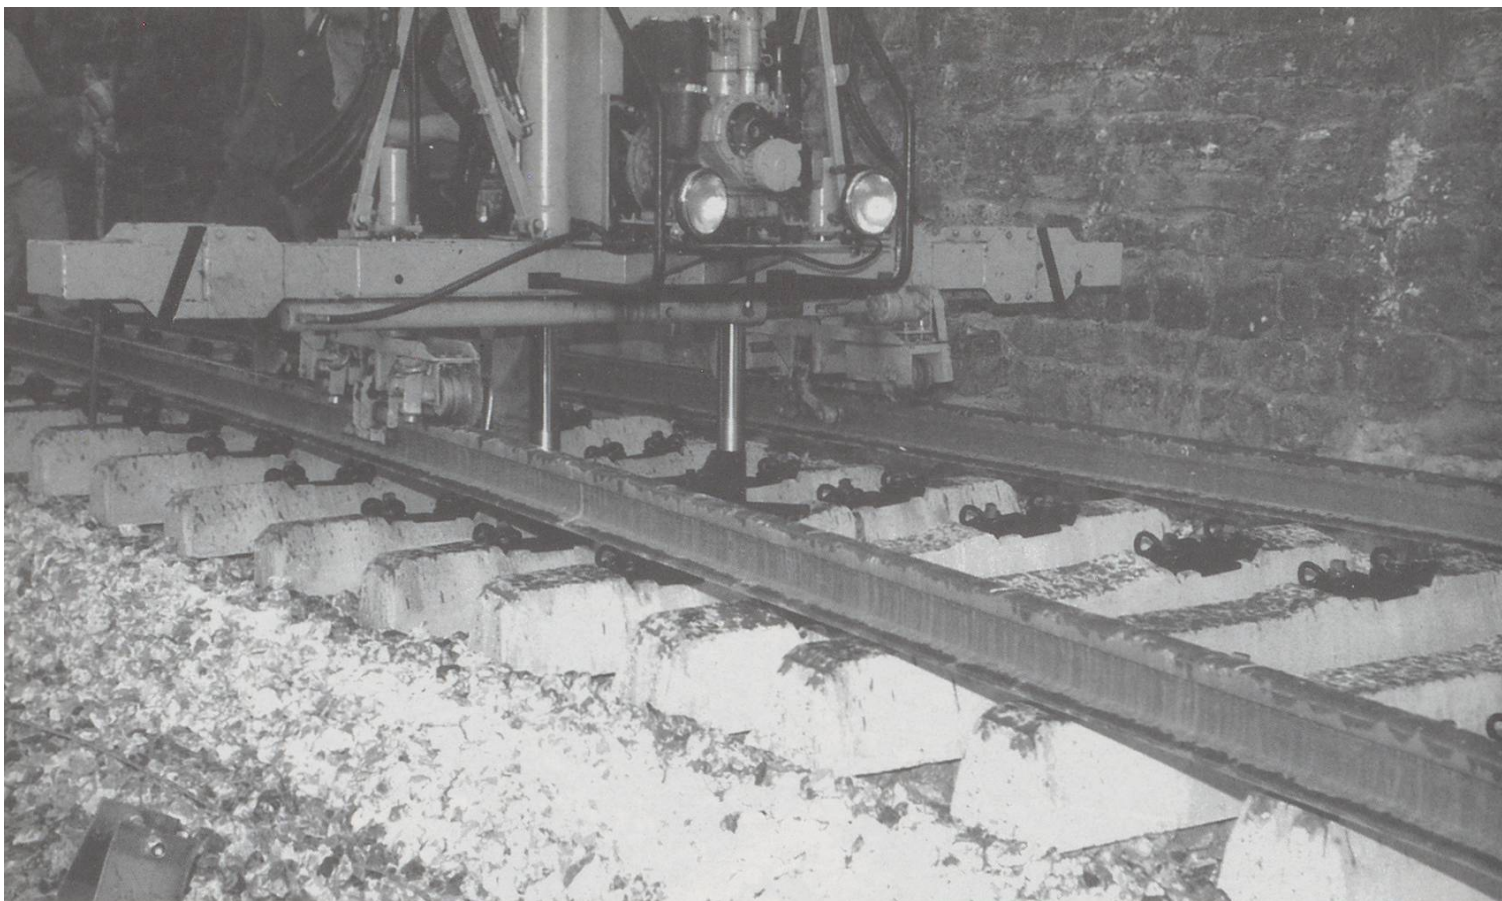
Below: The manual effort now begins, many long steel bars lift and push the new rails into position the small machine uses hydraulics to lift the rails onto the metal chairs.

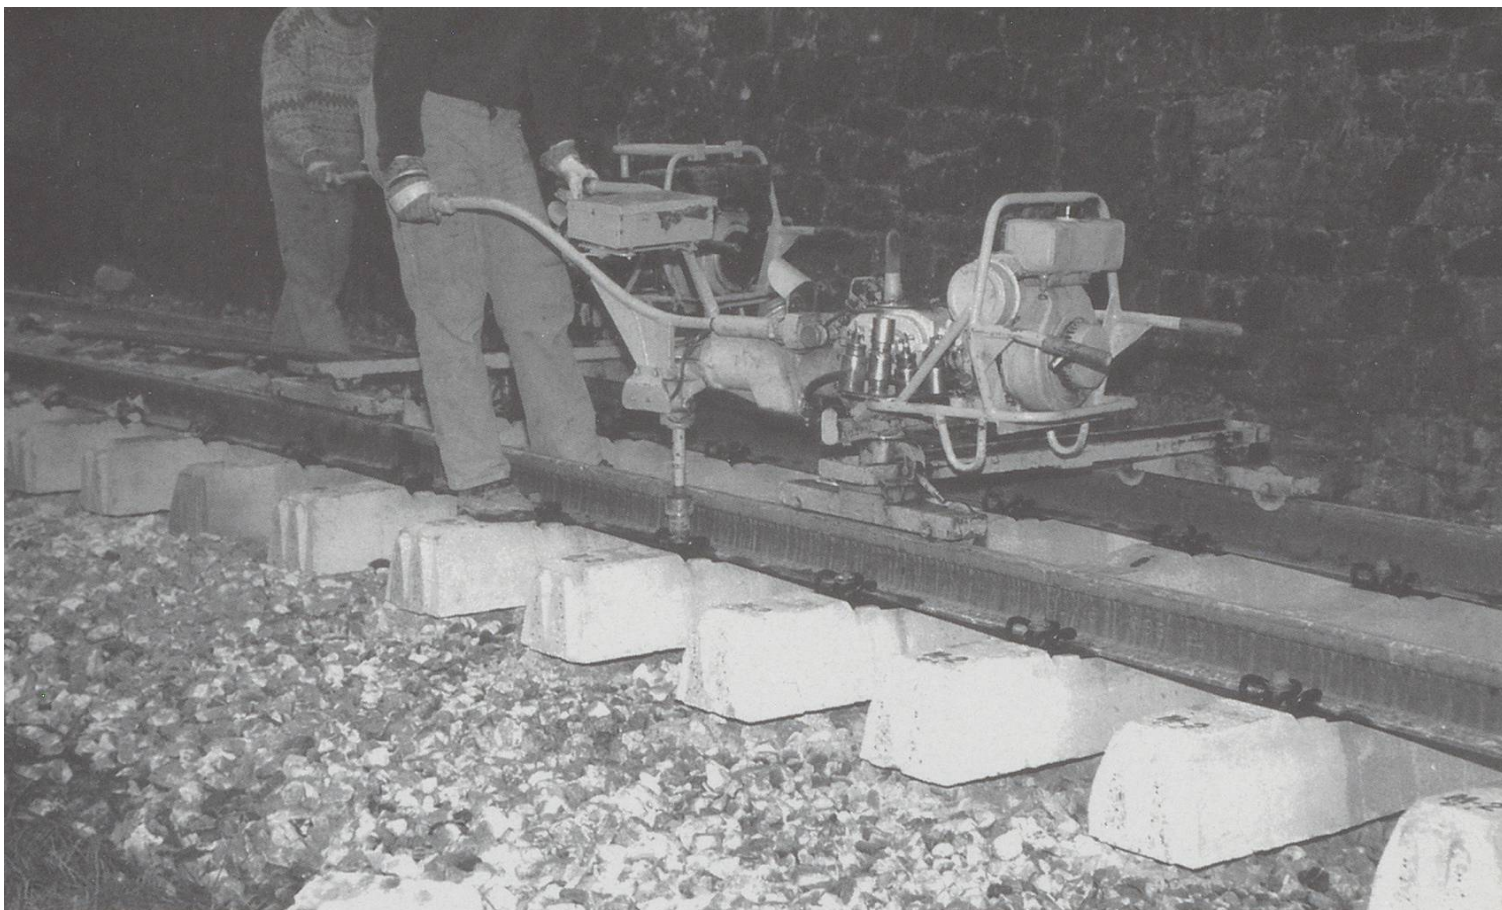
*Below:* The importance of placing the track back in exactly the same position as it came from not only affects the clearance from walls etc. but also where the pantograph connects with the overhead line.
