Zeitschrift: Swiss express : the Swiss Railways Society journal
Herausgeber: Swiss Railways Society
Band: - (2005)
Heft: [1]

FROM RUIN TO RACK

After a Complicated Road Journey Restoration begins on Europe's Largest Narrow Gauge Steam Rack Locomotive

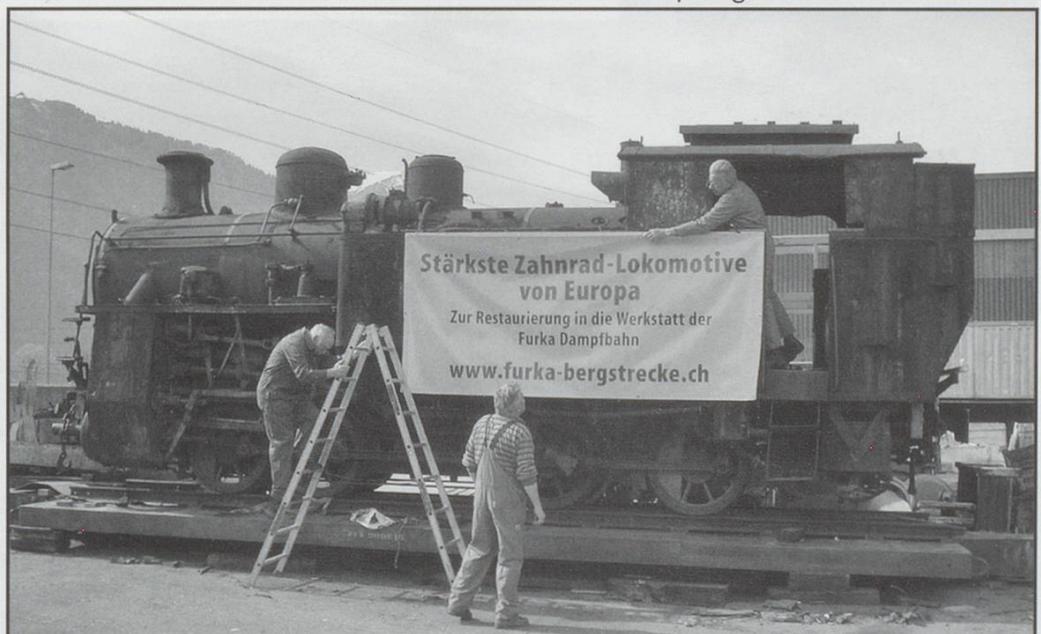
LEFT: The crane lifts the locomotive onto the trailer at Altdorf

large crane and a specially configured HGV and trailer owned by Wipfli AG, Flüelen arrived. The crane was set up and lifting chains were attached to the lifting "I" beams. The trailer had a section of metre-gauge track installed for the locomotive. The crane then proceeded to lift the 35-ton locomotive and place it on the transport trailer. The lifting beams were then removed, stored and the locomotive was secured with chains. During the move from Altdorf to Flüelen it was noticed that the tracks supporting the locomotive were showing signs of bending and a detour was made to the transport company's office and an additional support beam was placed under the rear of the locomotive.

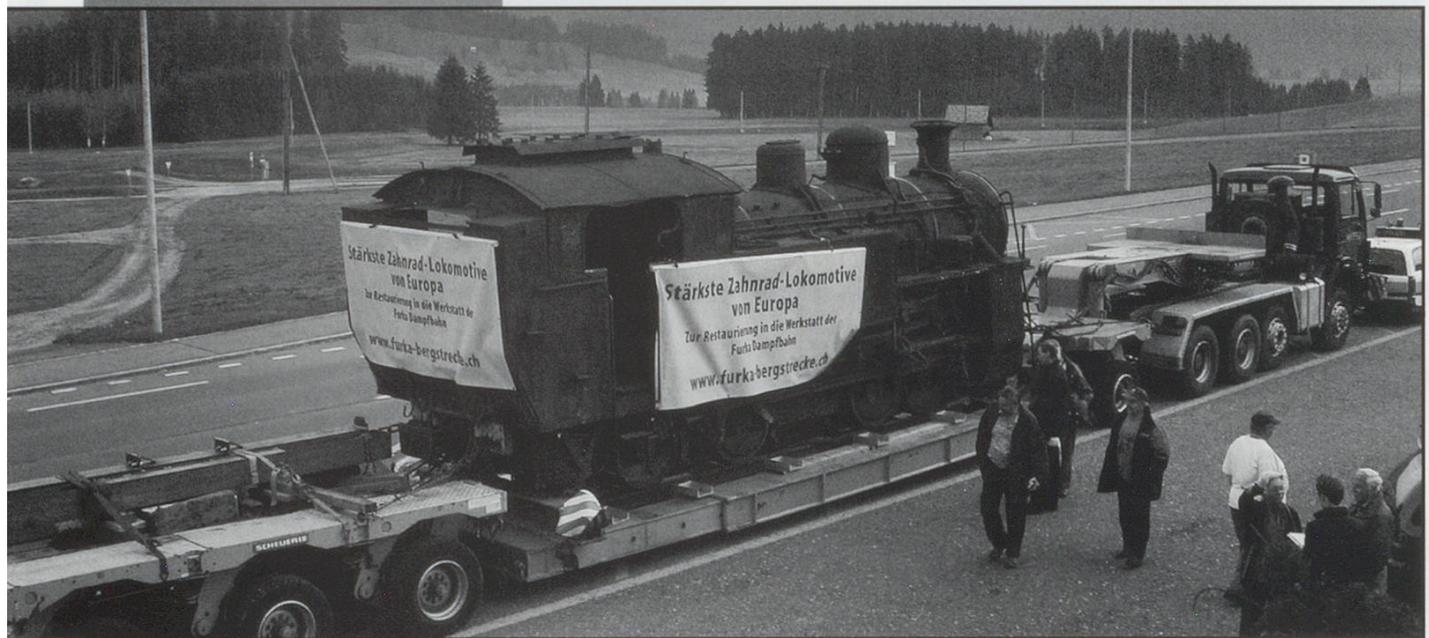
BELOW: The trailer is positioned under the hoists in the Chur workshop

The transport trailer had to be positioned very accurately, so that when the locomotive was unloaded its centre of gravity lay at the centre of the tracks in the workshop where the locomotive will rest during the restoration.

The large "I" beams were again attached to front and rear of the locomotive and using four synchronized electric 12,000 Kg floor lifts the locomotive was raised and the trailer was removed.
