Zeitschrift: Swiss express: the Swiss Railways Society journal

FROM RUIN TO RACK

After a Complicated Road Journey Restoration begins on Europe's Largest Narrow Gauge Steam Rack Locomotive

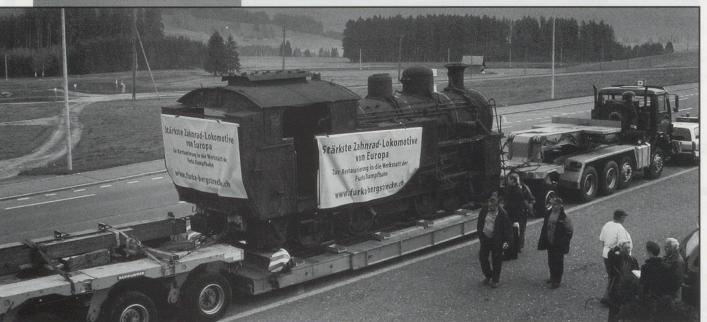
BELOW: The trailer is positioned under the hoists in the Chur workshop

The transport trailer had to be positioned very accurately, so that when the locomotive was unloaded it's centre of gravity lay at the centre of the tracks in the workshop where the locomotive will rest during the restoration.

The large "I" beams were again attached to front and rear of the locomotive and using four synchronized electric 12,000 Kg floor lifts the locomotive was raised and the trailer was removed.

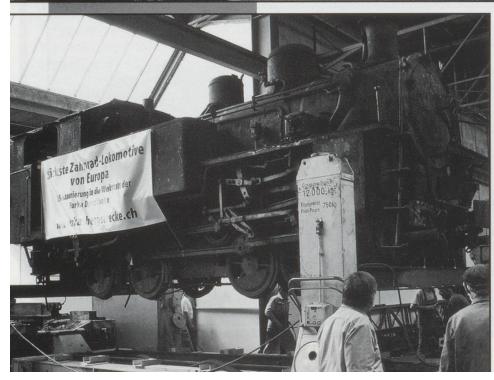
OPPOSITE UPPER: The turntable built to rotate the loco in the workshop

After several attempts and changes to the support configurations the locomotive was lowered onto the temporary tracks. The next challenge was the rotation of the locomotive 90 degrees without a crane. A small turntable, approximately one metre square was constructed which could support 60 tons. This is the reason the locomotive centre of gravity had to be determined so accurately. With the support beams placed on the turntable, the locomotive was then lowered on the turntable. Because the locomotive had had items removed the actual centre of gravity was unknown and it required a second try before the centre of gravity was located to enable the locomotive to be turned with no problem.
