Zeitschrift: Swiss express : the Swiss Railways Society journal
Herausgeber: Swiss Railways Society
Band: - (2014)
Heft: 120

Artikel: More on the 'Odd Man Out'
Autor: Jesson, John / Smith, Ron
DOI: <https://doi.org/10.5169/seals-854167>

More on the 'Odd Man Out'

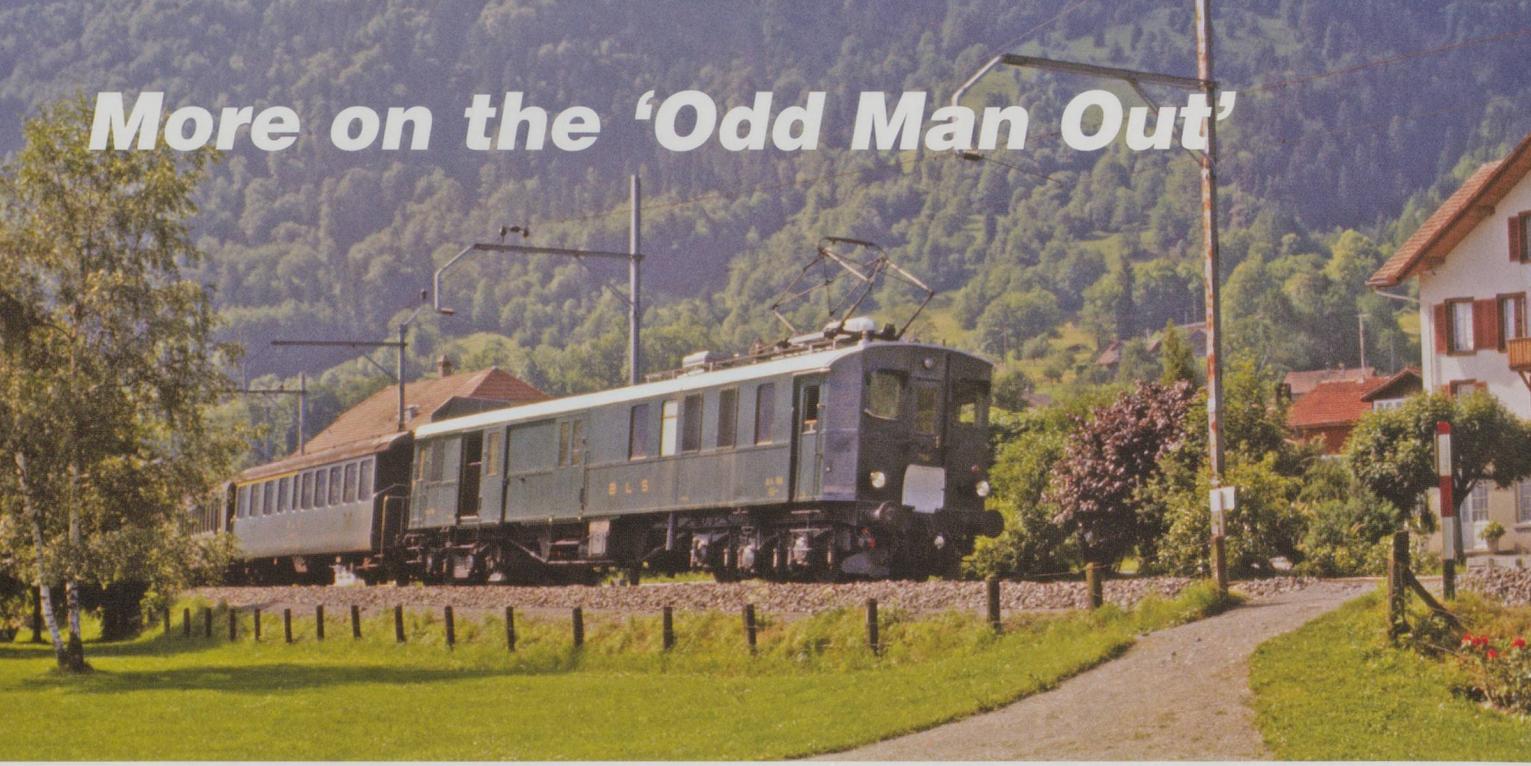
The 'Odd Man Out' article by Ron Smith in the September 'Swiss Express' about BLS De4/5 No.796 was very interesting. Like Ron, I cannot think of any other examples of asymmetrical wheel arrangements, although I have a nagging feeling that there was another somewhere in the world. In its later life No.796 had several differences from the five other examples of this design. When the new body was built for No.796, it had bigger cab windows, also windows in the angled cab corners. The others retained their smaller windows and solid cab corners. Additionally, No.796 had one less window in the body side (above the 2-axle bogie on one side), whereas the others, when rebuilt, retained this window. I think that No.796 was the only one of the class to be fitted with roof-mounted braking resistors and secondary suspension. Originally, each of the class had two pantographs, each with a single contact strip. Later, quite possibly during the rebuilding in the 1940's, they were replaced with a single pantograph with double contact strips. However, No.796 retained its second pantograph when rebuilt. I photographed it in 1969 with two pantographs, while a photograph in the

Stoltz book on BLS rolling stock taken in 1978 shows it with only one. Quite clearly, the vehicle now at Biasca is No.796 (it has the larger cab windows and the windows in the cab angles, and it has the secondary suspension), but it has regained its second pantograph and, curiously, they seem to have only a single contact strip. It also seems to have lost the roof-mounted braking resistors. I wonder when these alterations were done. I have a couple of pictures of the class. One, taken in 1969, shows No.796 leaving Spiez with a train to Zweisimmen, the other is of No.794 working a train from Interlaken towards Spiez just after departing from Därligen in June 1974. Incidentally, the grounds through which the railway runs are owned by the Hotel du Lac and crossing between the hotel and the lakeside required a great deal of care, especially as the line towards Spiez was bordered by hedges and electric trains are both quick and quiet.
