**Zeitschrift:** Swiss express : the Swiss Railways Society journal  
**Herausgeber:** Swiss Railways Society  
**Band:** - (2015)  
**Heft:** 122

# The Simplon Tunnel

## Part 2 - The second bore

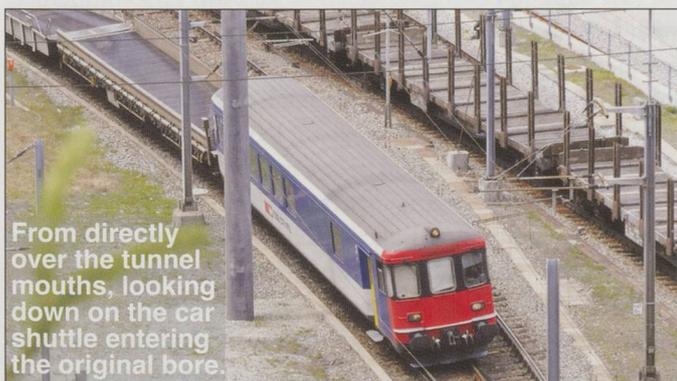
From directly over the tunnel mouths, looking down on the car shuttle entering the original bore.
