The Simplon Tunnel

Part 2 - The second bore

John Jesson

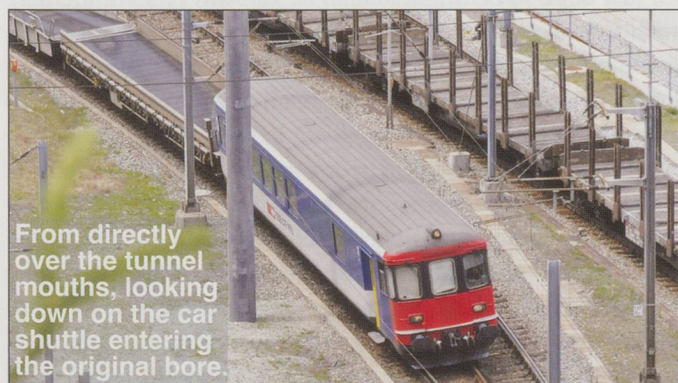
From directly over the tunnel mouths, looking down on the car shuttle entering the original bore.
