Zeitschrift: Swiss express: the Swiss Railways Society journal

Artikel: Brienz Rothorn Bahn : a Swiss heritage railway goes searching for old

skills

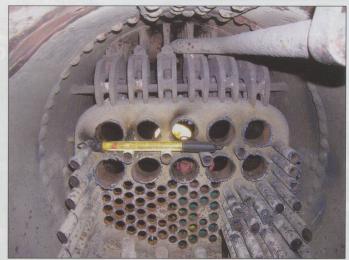
TOP: A great view taken inside the boiler. Here we see that the tubes have been cut away leaving only the ends to remove. The inner firebox construction (not original) is held in position at the top by the anchor brackets which allow for expansion movement. The steam pipe mentioned in the main text is the tube positioned top right. This connects the steam cavity in the dome to the regulator.

For the technically minded the work was to include: removal of the 'new' welded firebox installed in the 70's; removal and replacement of all boiler tubes; replacement of the steam pipe; renovation of the foundation ring; replacement of the inner firebox with a new copper (riveted) firebox as per original design circa 1932; new front tube plate and sundry other work. All in all a major rebuild to an old component. Would the Swiss Inspector, accept the plan? Richard and Steven were maybe a little too confident. Daniel and Mike were maybe a little too nervous and one poor translation between the English and Swiss German could screw it all up... Towards the end of the meeting Herr Kehrli, the Inspector, turned to me as the meeting translator. He clarified: We wanted to take an 85 year old boiler to England, dismantle it, replace and rebuild 60% of the construction, and, that with riveted not welded joints! And, to a design from 1932...? Were we serious? As calmly as I could, I said
