# BRIENZ ROTHORN BAHN

A Swiss Heritage Railway goes searching for old skills

Michael Ellis

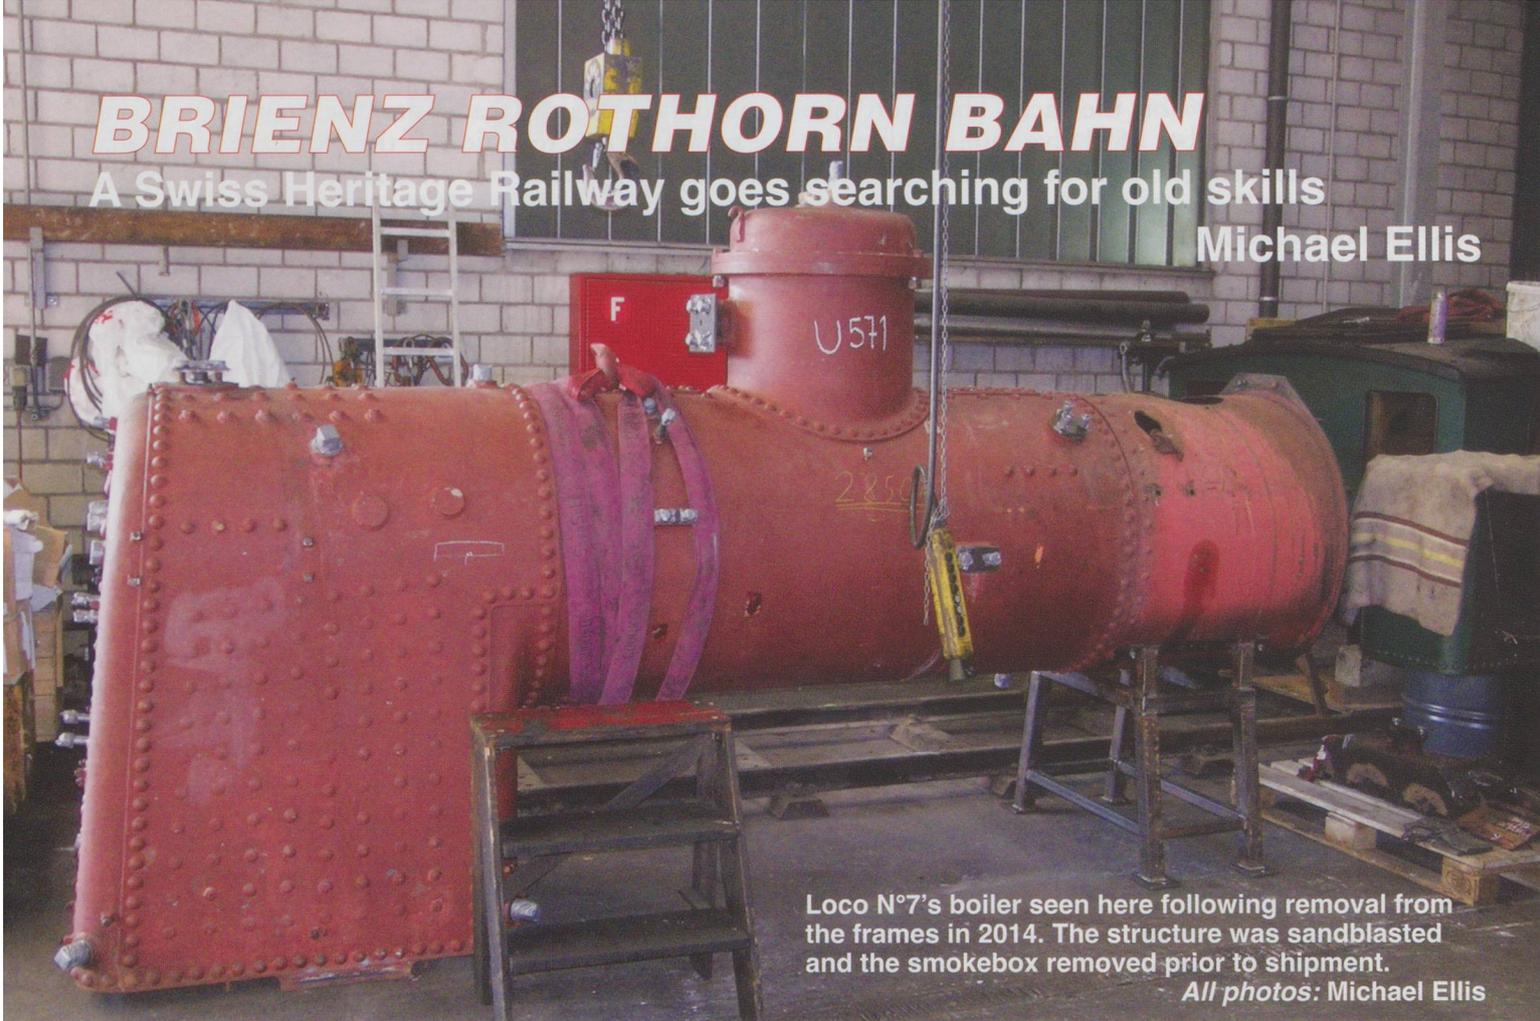
Loco N°7's boiler seen here following removal from the frames in 2014. The structure was sandblasted and the smokebox removed prior to shipment.

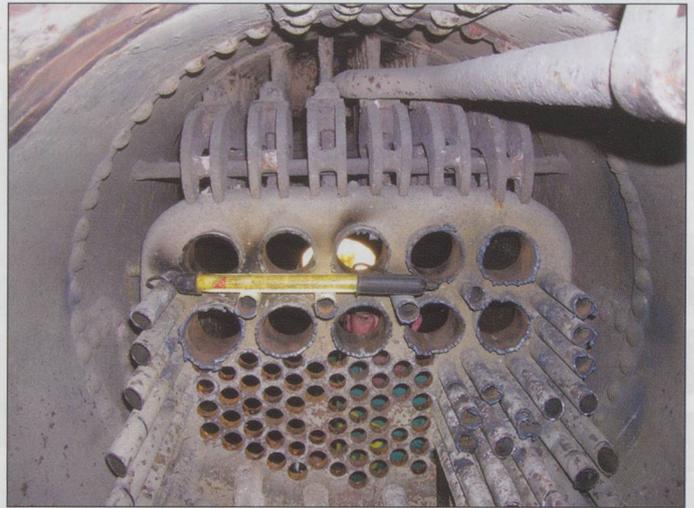
**TOP:** A great view taken inside the boiler. Here we see that the tubes have been cut away leaving only the ends to remove. The inner firebox construction (not original) is held in position at the top by the anchor brackets which allow for expansion movement. The steam pipe mentioned in the main text is the tube positioned top right. This connects the steam cavity in the dome to the regulator.

For the technically minded the work was to include: removal of the 'new' welded firebox installed in the 70's; removal and replacement of all boiler tubes; replacement of the steam pipe; renovation of the foundation ring; replacement of the inner firebox with a new copper (riveted) firebox as per original design circa 1932; new front tube plate and sundry other work. All in all a major rebuild to an old component. Would the Swiss Inspector, accept the plan? Richard and Steven were maybe a little too confident. Daniel and Mike were maybe a little too nervous and one poor translation between the English and Swiss German could screw it all up... Towards the end of the meeting Herr Kehrli, the Inspector, turned to me as the meeting translator. He clarified: We wanted to take an 85 year old boiler to England, dismantle it, replace and rebuild 60% of the construction, and, that with riveted not welded joints! And, to a design from 1932...? Were we serious? As calmly as I could, I said

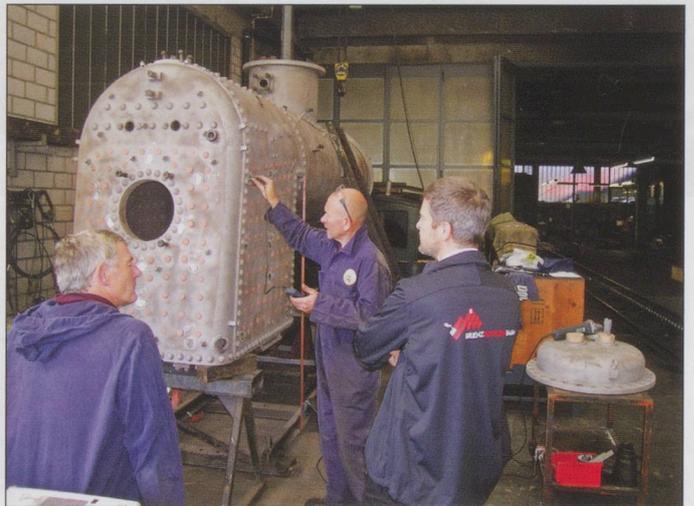
**MIDDLE:** Steven Latham from L&NWRH is seen here conducting the ultra sonic measurement of the outer firebox wall thickness. In places 85 years use had resulted in 0.7 mm erosion of 13 mm thick steel plate, still well within acceptable limits. L – R Richard Watkins, Steven Latham, Mike Ellis.

L&NWRH despatched Works Manager Steven Latham and Richard Watkins, his 'encyclopaedic' Boilersmith, to Brienz. The visit enabled them to undertake ultrasound tests and initially assess the boiler in order to advise us of what hidden horrors existed beneath the surface. This visit concluded with a meeting to which the Swiss Boiler Inspector was also invited, as his OK to the project was paramount.

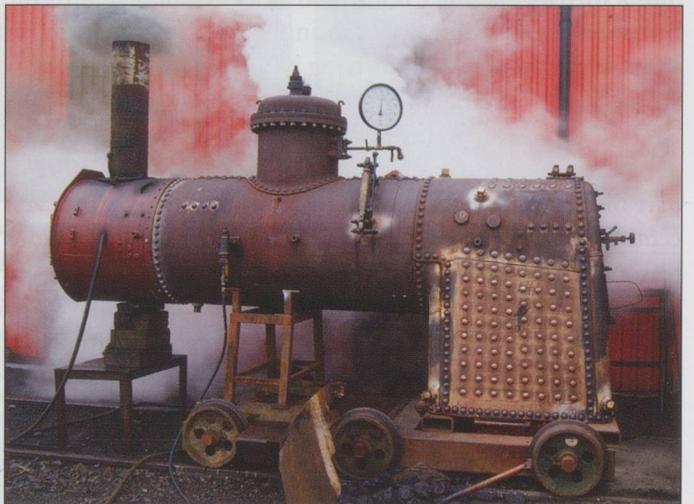
**BOTTOM:** Looking like an artefact from the next Mad Max movie the boiler of N°7 reaches test pressure. The lighter platework clearly shows the outer work undertaken by L&NWRH.

The plan is to have Loco No.7 back in traffic during 2016. It's a tight schedule and was dependant upon the boiler returning by February 2016. L&NWRH responded in style and during the Christmas period brought the work to a close. The cold hydraulic test was made and passed on the 18th January and on the 21st the BRB team returned to Crewe to witness the steam test. With the boiler held to the smokebox with two temporary bolts, and the whole sitting on an old trolley, it only required 4 of old GWR signal post to serve as a chimney and get a good fire going. Three hours later the first valve lifted and the job was done! From the perspective of one involved in the centre of all communications and decisions between Brienz and Crewe, it has been a well-delivered contract. It looks as though we will be on budget, on time and with a quality of work that reflects the immense amount of experience and engagement that the team at L&NWRH brought to the project. The documented project and experience gained will also enable the BRB to provide future consulting support to other similar projects within Switzerland, whilst future BRB projects are already planned. My personal thanks go to all concerned, whether mentioned or not, for assistance during the project and for information used in this article. For further information on the project email [Michael.ellis@brb.ch](mailto:Michael.ellis@brb.ch)
