# Kaitavesi Bridge, Tampere (Finland)

#### 4. Kaitavesi Bridge, Tampere (Finland)

<b>Owner:</b>	<i>Finnish Roads and Waterways Administration (RWA)</i>
<b>Design:</b>	<i>RWA and Insinööritoimisto Pontek Ky</i>
<b>Contractor:</b>	<i>Perusyhtymä Oy</i>
<b>Construction Work Duration:</b>	<i>10.5 months</i>
<b>Completion:</b>	<i>1983</i>

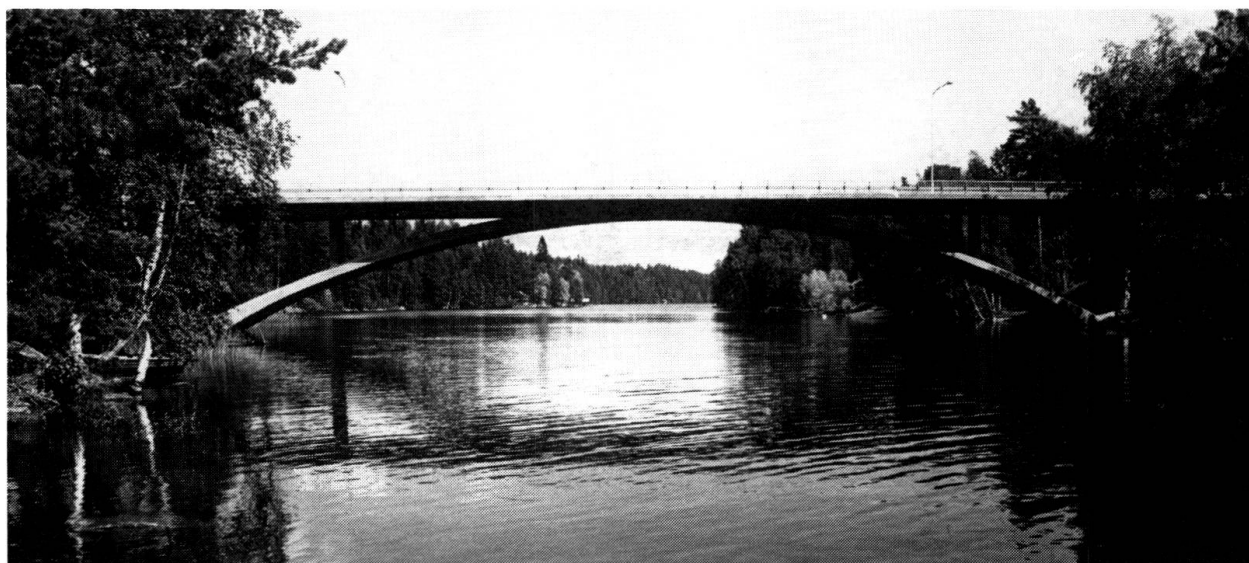
Fig. 1 Kaitavesi bridge

Since the bridge had to harmonize well with the landscape as well as with the old bridge, appearance requirements for the new bridge were high. Of several alternatives a reinforced concrete combined slab and open spandrel arch bridge was chosen. Its total length is 110.8 m and the arch spans 73.5 m. At one end the slab spans are  $3 \times 14.0$  m and  $3 \times 13$  m at the other. At midspan, the slab and arch join, forming a monolithic structure for a distance of 23.4 m. The horizontal clearance is 10.5 m. The rise-span ratio of the arch is only 1:7.3.

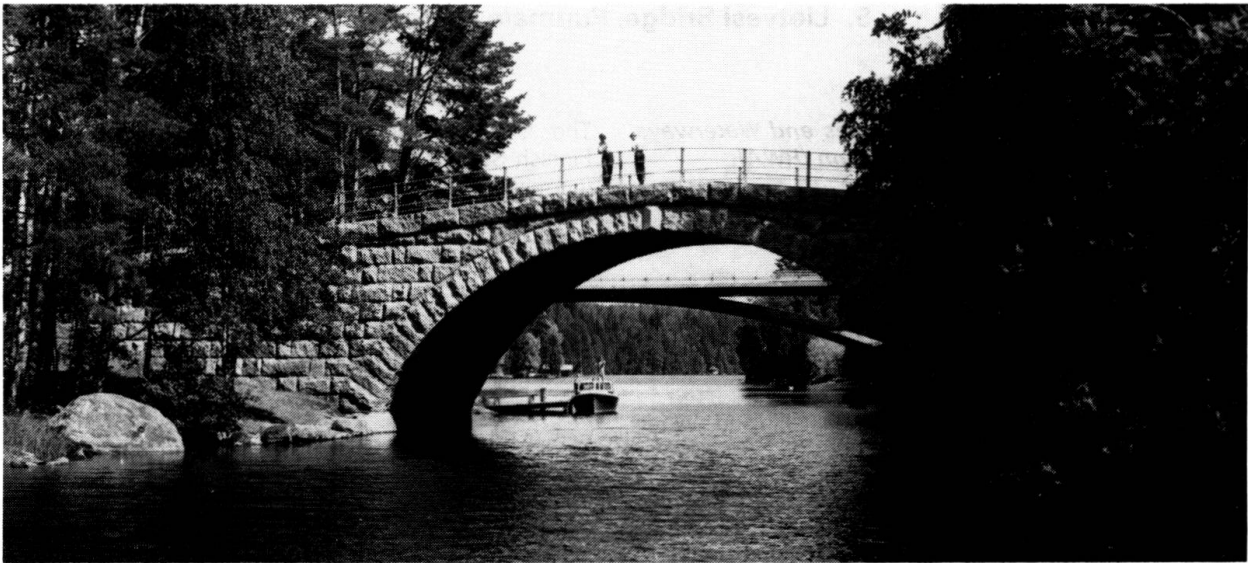
*Fig. 2 The old Aunessilta bridge. Kaitavesi bridge is in the background*

Aunessilta bridge, constructed in 1899, situated 25 km northeast from the center of the town of Tampere, is one of the most beautiful stone vault bridges in Finland. Its span is 19.0 m wide at water level and the clear headway at midspan is 6.0 m from flood level. The bridge is in very good condition, however, it was too narrow for the present traffic. Its horizontal clearance is only 4.6 m, and sight distances at the bridge are too short due to the bulging shape of the upper surface of the bridge.
