Survey of structures by using acoustic emission monitoring

Zeitschrift: **IABSE reports = Rapports AIPC = IVBH Berichte**

Band (Jahr): **39 (1982)**

Survey of Structures by Using Acoustic Emission Monitoring

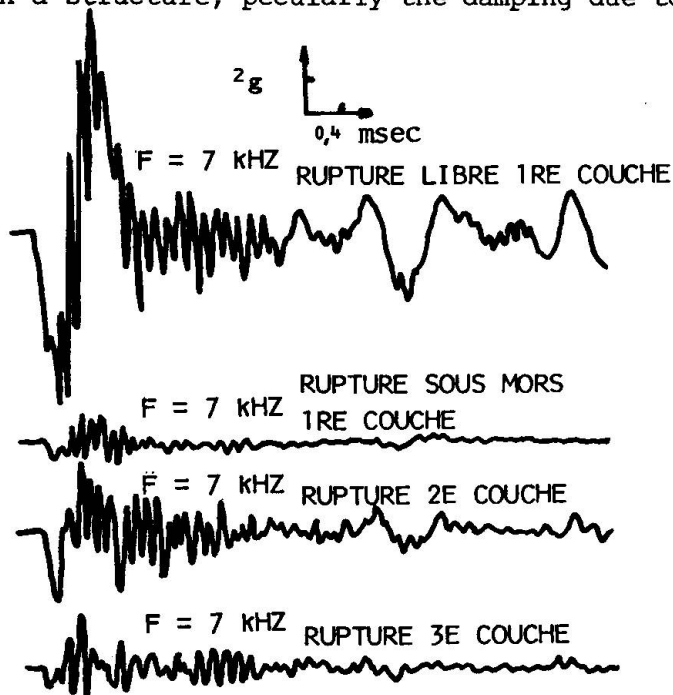
FIGURE N° 1 - Recording of the first wave in various cases of individual wire fracture in a cable, at 21 m far from the breaking point

The experimental method consisted in inducing, at a given point, the individual fracture of internal and external wires in tensioned cables and in recording the produced waves (fig. 1) at various distances of the breaking point, by using accelerometers in order to determine the properties (frequency, amplitude, damping versus distance). In a parallel way, we searched a simple mean for producing similar waves in a cable, so that we could study the propagation conditions in a structure, pecularly the damping due to suspenders and suspender catches.

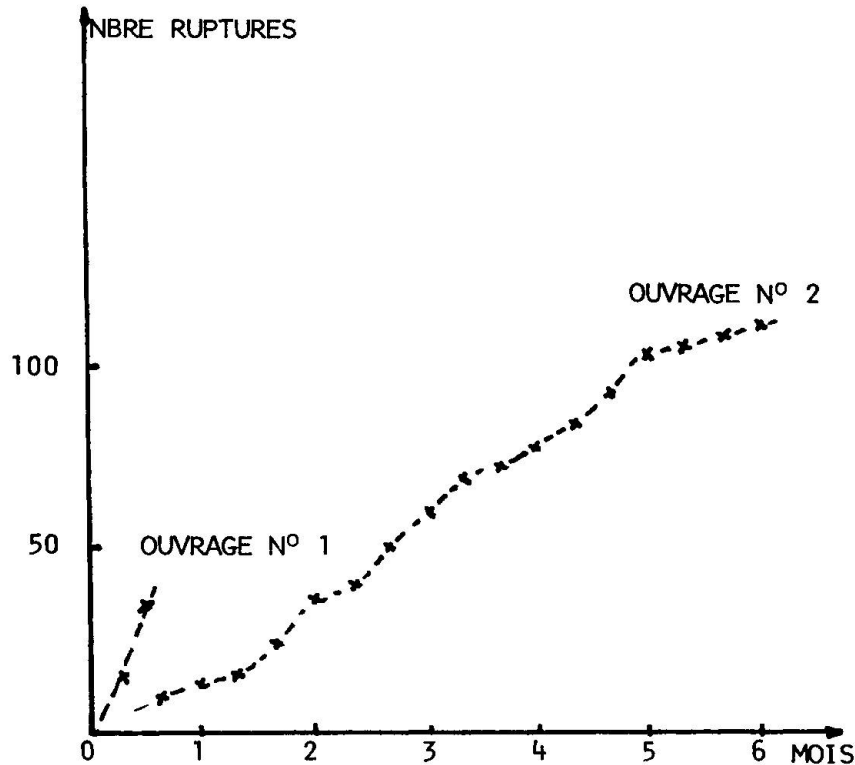
FIGURE N° 2 - Number of fractures monitored by acoustic survey of cables in two suspension bridges (on service)

In this area, the number of fractures monitored with the acoustic survey was 1 for a day, as a mean value, from July to December. Then the phenomenon seemed to be stabilized, starting from December.

After the cable removal, a 5 m long piece, where the acoustic emission had monitored 10 fractures, was examined : 63 fractures were observed in the internal layers (the external layer being perfectly safe). This result enabled us to verify the validity of the acoustic survey of the suspension bridge cables, which makes it possible to monitor the individual fracture of elementary wires at the time when it occurs, with a location precision in the order of 0,10 m.
