Zeitschrift: IABSE reports = Rapports AIPC = IVBH Berichte

Band (Jahr): 66 (1992)

# **Fatigue Strength of Wires**

Yoshito TANAKA
Dir., Eng. Div.
Shinko Wire Co, Ltd
Amagasaki, Japan

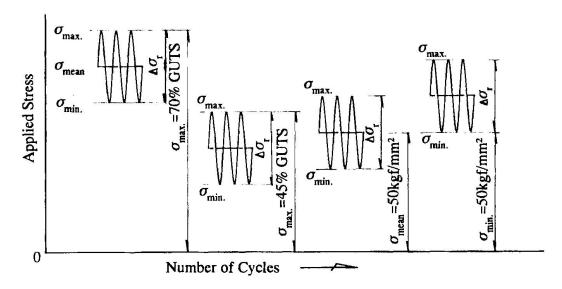
Fig. 2 Examples of the Definitions of Stresses in Fatigue Tests

Many fatigue tests have been done for prestressing wire in the past and the test results are available. However, testing conditions are not necessarily unified and the direct comparison of the various test data is very difficult. ISO 6934-2 calls for a fluctuating stress down from maximum stress of 70% of the nominal tensile strength; many of the specifications for stay cables prescribe a maximum stress of 45% of GUTS; some other tests have been carried out at a minimum stress of 50 kgf/mm², and so on. Fig. 2 illustrates some examples of the definitions of the stress in fatigue tests.

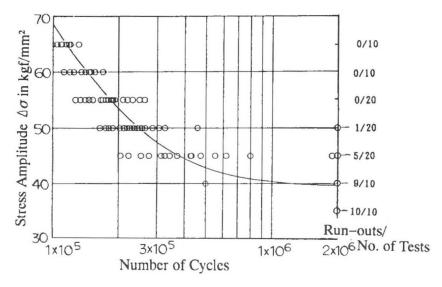
Fig. 3 An Example of Fatigue Test Results for a 7 mm Prestressing Wire

Fig. 3<sup>(5)</sup> is an example of a fatigue test result for 7 mm dia. prestressing wire at a mean stress of 50 kgf/mm<sup>2</sup> (490 N/mm<sup>2</sup>). The endurance limit is determined to be 40 kgf/mm<sup>2</sup> or 392 N/mm<sup>2</sup>. Combining with other test results, and assuming that the distribution of the data follows the normal distribution, it is reported that a 5% fractile fatigue strength for the wire to be 36 kgf/mm<sup>2</sup> or 354 N/mm<sup>2</sup>.

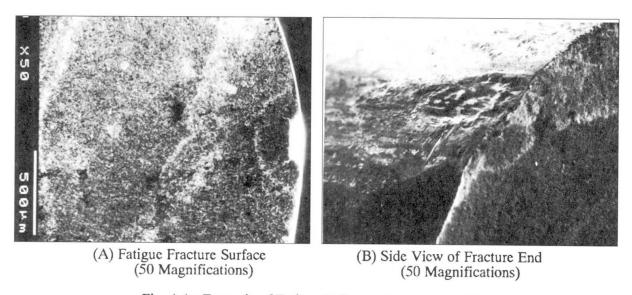
Fig. 4 An Example of Fatigue Failure of Prestressing Wire

The two photographs of Fig. 4 (A) and (B) show a typical example of a fatigue failure of the prestressing wire. It is obvious that the fatigue failure started at a surface flaw that was present before it was subjected to the fatigue test.

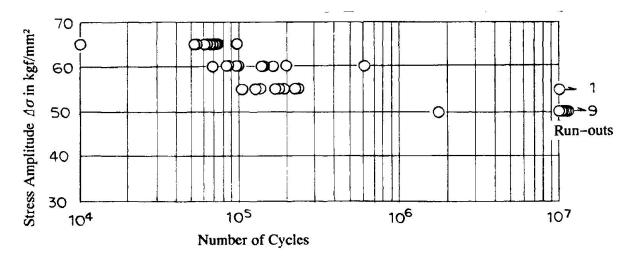
Fig. 8 Fatigue Test Result for 7 mm Dia. Galvanized Wire at a Mean Stress of 50kgf/mm<sup>2</sup> (490N/mm<sup>2</sup>)

To establish S-N diagram for the galvanized wire, fatigue tests were carried out using 200 mm long specimens on a 10 ton capacity electro-servo type fatigue tester. Fatigue test results are given in Figs. 8 and 9 for the mean stresses of 50kgf/mm² (490 N/mm²) and 100kgf/mm² (980 N/mm²), respectively.

The fatigue tests are still under way to establish a statistical analysis. However, the number of he test data available to date is not enough to permit a statistical calculation of the fatigue values and so we have to guess the endurance limit from the S-N diagrams. It is considered that the endurance limits are 50 kgf/mm² (490 N/mm²) and 40 kgf/mm² (392 N/mm²) for the mean stress of 50 kgf/mm² (490 N/mm²) and 100 kgf/mm² (980 N/mm²), respectively.

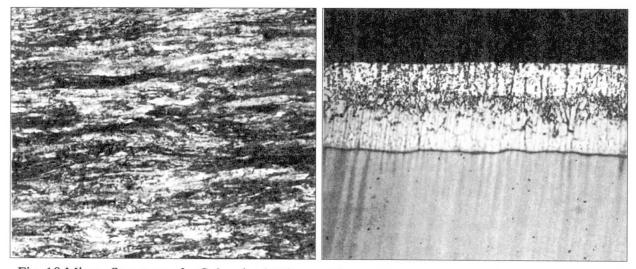
Fig. 10 Micro-Structure of a Galvanized Wire (400 Magnifications)

Fig. 10 is a micro-structure of the galvanized wire. This is a typical fiber structure and is idential with that of the prestressing wires. Note that the micro-structure is entirely different from he one shown in Fig. 6 for oil tempered wire. Fig. 11 is a micro-structure of the zinc coating.
