Zeitschrift: IABSE reports = Rapports AIPC = IVBH Berichte
Band: 70 (1993)

Early Modern Architecture: How to Prolong a Lifespan

Wessel DE JONGE

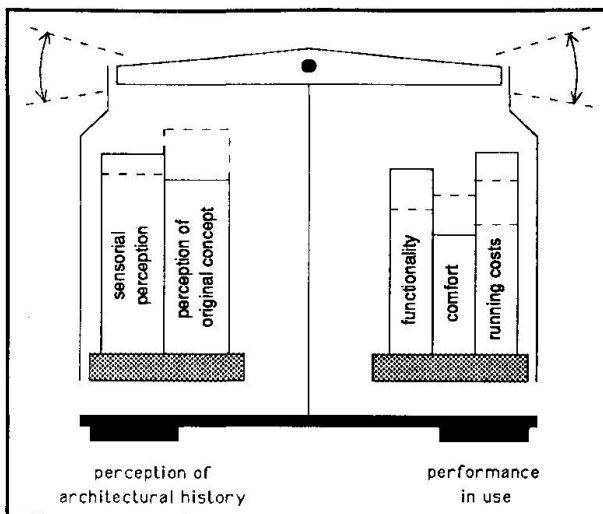
Fig. 3. The key problem is to maintain the correct balance between performance in use and the perception of architectural history. The original design approach is an indispensable element.

Each intervention has an impact on the balance between perception and use. The key problem is to maintain the correct balance between the intangible factors and the practical use. In order to determine this balance the numerous conceivable forms of intervention are classified and reduced to a number of intervention models, each with another philosophy:

- Model I: Restoring it uncompromisingly to its original state. This might be impossible technically. Still, it is an interesting option for comparison with other models.
- Model II: A variant of model I, but with small, imperceptible technical improvements.
- Model III: Pragmatic restoration, where changes in the nature of the building are introduced using contemporary methods and conceptions of architecture.
- Model IV: 'Ordinary' reuse for economic reasons; there is no question of restoration.
